# Preservation Assessment Report: Louise Pettus Archives

**Dacus Library (Room 02) – TWPI = 44 years**

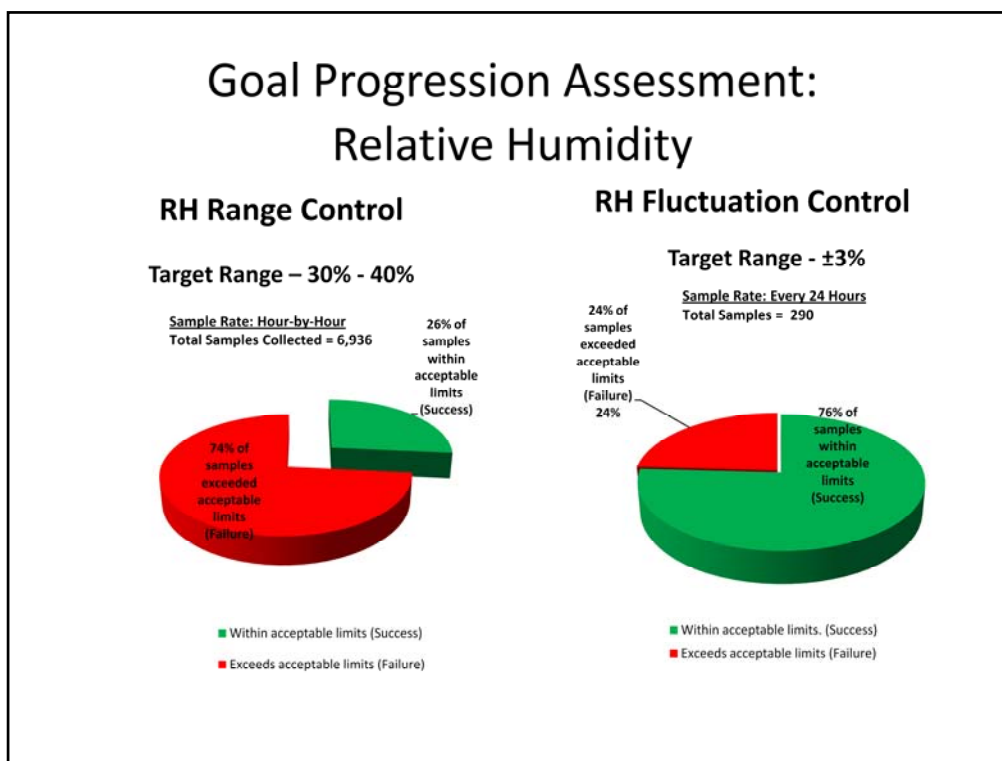
### Slide #6 – Goal Progression Assessment: Relative Humidity

The two colored side-by-side pie charts on this slide reveal a similar pattern for relative humidity. The red colored pie slice in the chart on the left represents a 74% failure rate to control relative humidity levels within 30 to 40%. The green colored pie slice in the chart on the right represents a 76% success rate to maintain control of relative humidity fluctuations within a range of plus or minus 3% in a 24-hour period. Again, note the inverse relationship between the two. As noted for temperature, these findings suggest that more could be done to maintain relative humidity levels within the specified 30 to 40% range. And as was just noted for temperature control, there is an understood “trade-off” between controlling relative humidity within a specified range and maintaining control of RH fluctuations. The long-term need here is to find a careful balance so that adjusting relative humidity levels has a positive impact to increase the overall TWPI value to acceptable levels. This can be done by calibrating the existing HVAC so that it operates at peak efficiency within its design specifications so that there is a balance between target goals as closely as possible.

Unfortunately, most HVAC systems are designed to efficiently regulate and maintain temperature levels and there is little regard to regulating relative humidity levels. And using applied heat to reduce relative humidity levels compromises attempts to reduce temperature levels. This is probably the same system design for the Dacus Library’s present HVAC system. But there are other complicating factors that deter the archive’s long-term preservation needs.

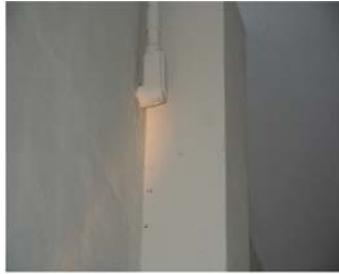
### Slide #8 – Problem #1: Drainage and Leaks

Drainage problems and leaks are a continuing problem in the emergency exit access basement area located outside of Room 02, the archives' primary archival storage area. The first picture on the left shows water leaking from a junction box in the emergency exit stairwell outside of Room 01 and Room 02. This picture was taken during late Monday morning on May 31<sup>st</sup> during a recent rainstorm that occurred throughout the day.

The picture on the right is a close-up photo of a 2 inch gap between power conduit and local area network drop. This gap begins on the 2<sup>nd</sup> floor HVAC room, continues through the main floor HVAC room located in technical services, and it runs through to the basement level where Room 02 storage is located. The picture on the bottom of the slide shows the gap from a different perspective. This photo image was captured on May 17<sup>th</sup> in the HVAC room on the main floor just above Room 02 following a flooding event. Note the light shining through the 2 inch gap for the hole containing the power conduit line and local area network drop. The whole is flush with the floor creating a drain for water. When flooding occurs, water containment becomes a serious issue as noted in the next slide.

- Drainage and Leaks
  - Use controlled methods to identify leaks sources.
  - Replace ceiling tiles in all storage areas.
- Water Containment
  - Apply sealant putty to all gaps.
- Preventive Maintenance & Inspections
  - Ceiling tile replacement.
  - Daily inspections of HVAC rooms.
  - Posted maintenance schedules.

The resolution to these immediate factors is quite simple and cost effective. Using controlled methods to identify the source or sources of these leaks is a crucial first step. Once those leaks are identified, then the next step is to apply sealant putty to all known gaps so that water can be self-contained when flooding events occur. Also, ceiling tiles in Room 02 need to be replaced so that archives staff can identify if leaks continue. Ceiling tiles also act as a natural absorbent to prevent archival materials from being saturated by moisture and water. As a preventative measure, the HVAC rooms should be inspected on a daily basis to ensure that there aren't any flooding issues and so they can be reported immediately when they do occur. The burden of this task can be assigned to a designated library staff person. Also, the library should be notified about any maintenance scheduled for the HVAC units in the library so that they will know about the impact and temporary disruption that impacts the preservation environment. Correcting these known problems represents a first step toward a long-term solution to improve preservation standards in the archives.

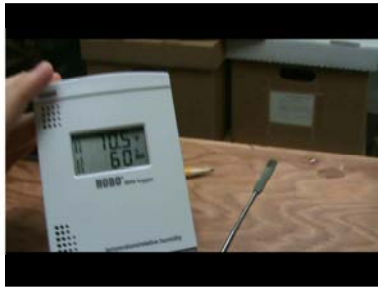
### Slide #9 – Problem #2: Water Containment

The top images on the left and right were captured on May 17<sup>th</sup> in Room 02 following a flooding incident that was discovered the same day. Flooding occurred on the floor above and drained down into the basement level. These flooding events are extremely detrimental to preservation efforts for the materials stored in the basement. The captured image at the bottom is the archive's data logger that shows a temperature level of 70.5 degree Fahrenheit and 60% relative humidity. These levels far exceed preservation target goals and are at levels high enough to encourage active mold blooms to occur. Though some of these known problems may be anomalies, some of those problems may have been prevented.

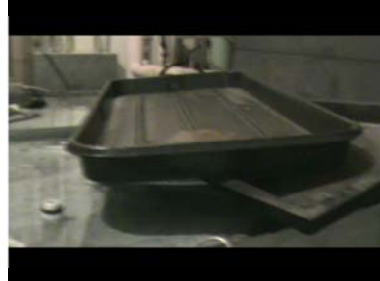
### Slide #10 – Problem #3: Preventative Maintenance and Inspections

The image on the left is standing water resting on top of the HVAC unit housed in technical services. The image to the right is of 2 condensate drip pans. Was the water cleaned up or was it allowed to remain? Why are the condensate pans there? A dialogue of open communication between facilities and archives staff needs to be established on an ongoing basis so that preventable problems can be identified before they lead to bigger problems. Knowing when and what type of preventative maintenance routines provide the type of background information needed to identify known cause and effect relationships of temperature and relative humidity levels and fluctuations. Knowing when these events occur and how they affect the controlled environment helps archives staff to know precisely how and when temperature and relative humidity spikes or drops occur due to maintenance. Also, knowing that the HVAC systems throughout the building are maintained at peak operating efficiency provides archives staff with the assurance that these systems are performing to the best of their limitations to regulate temperature and relative humidity control.
